Technical Memorandum 8
Existing
Geometric Conditions Evaluation

Technical Memorandum 8

Geometric Conditions Evaluation

This document was prepared by Atkins for the
Tennessee Department of Transportation
Project No. 99108-1154-04

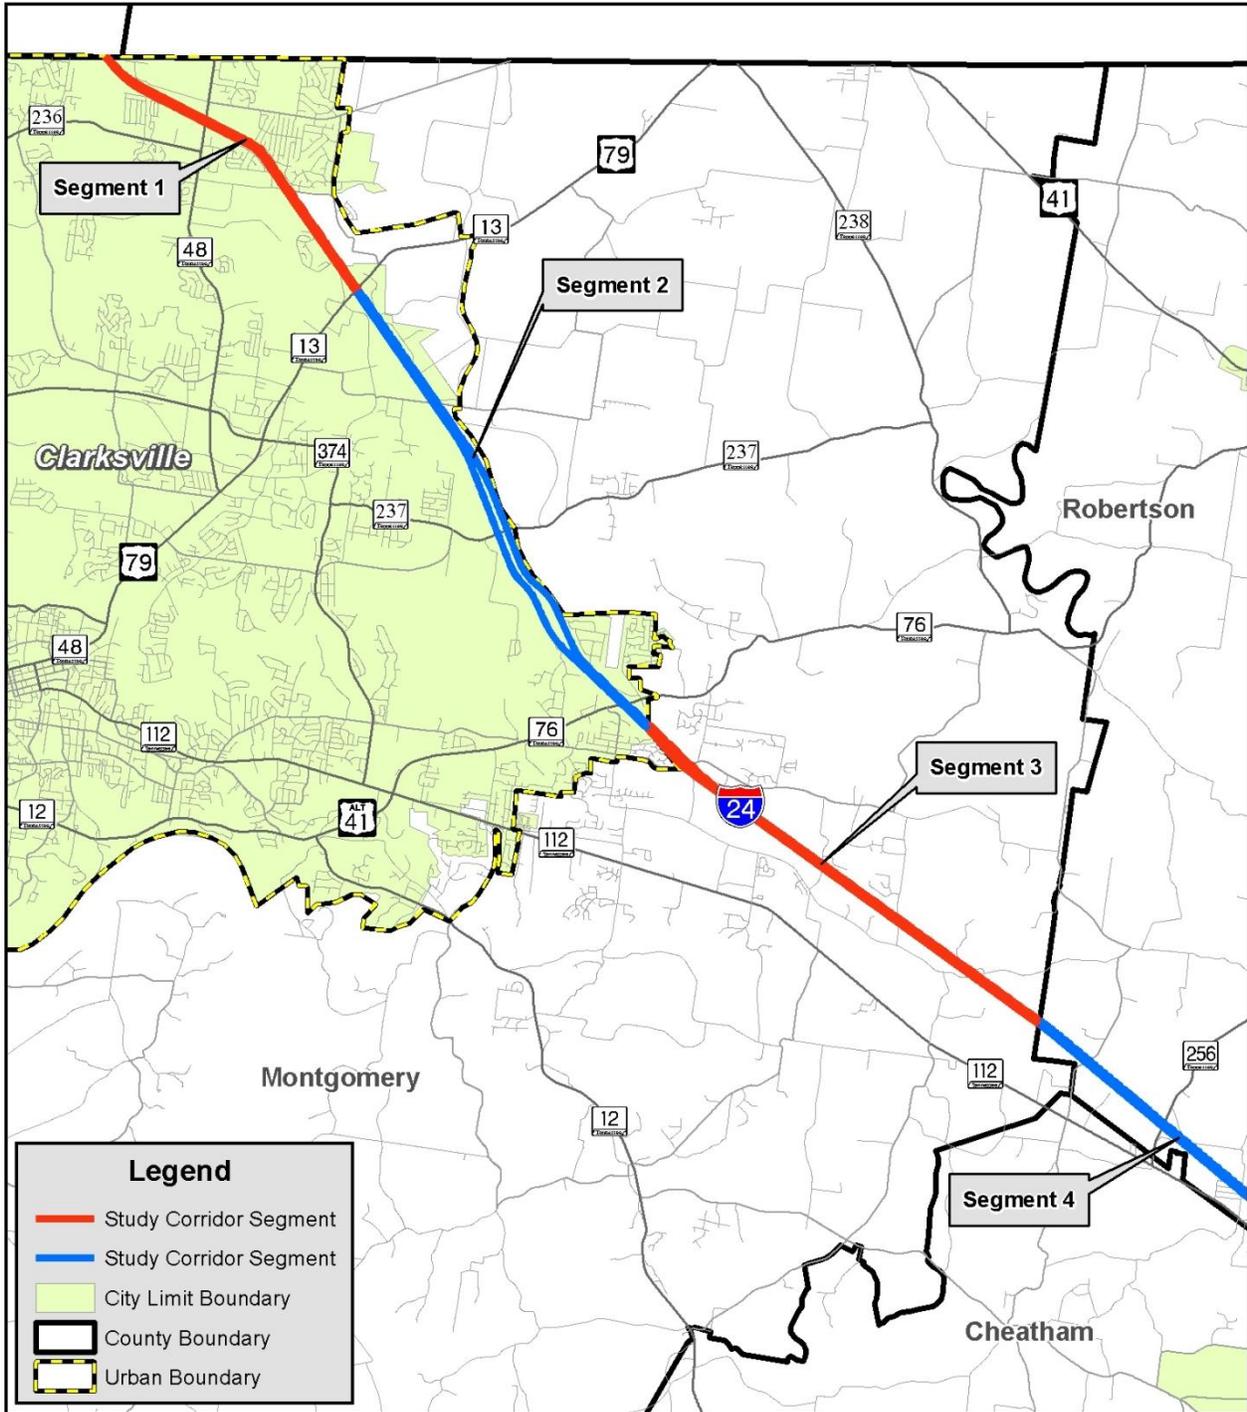
Figure 2.1: I-24 Corridor Segments - Montgomery and Robertson Counties

**Interstate 24 Corridor Segments
Montgomery and Robertson Counties**

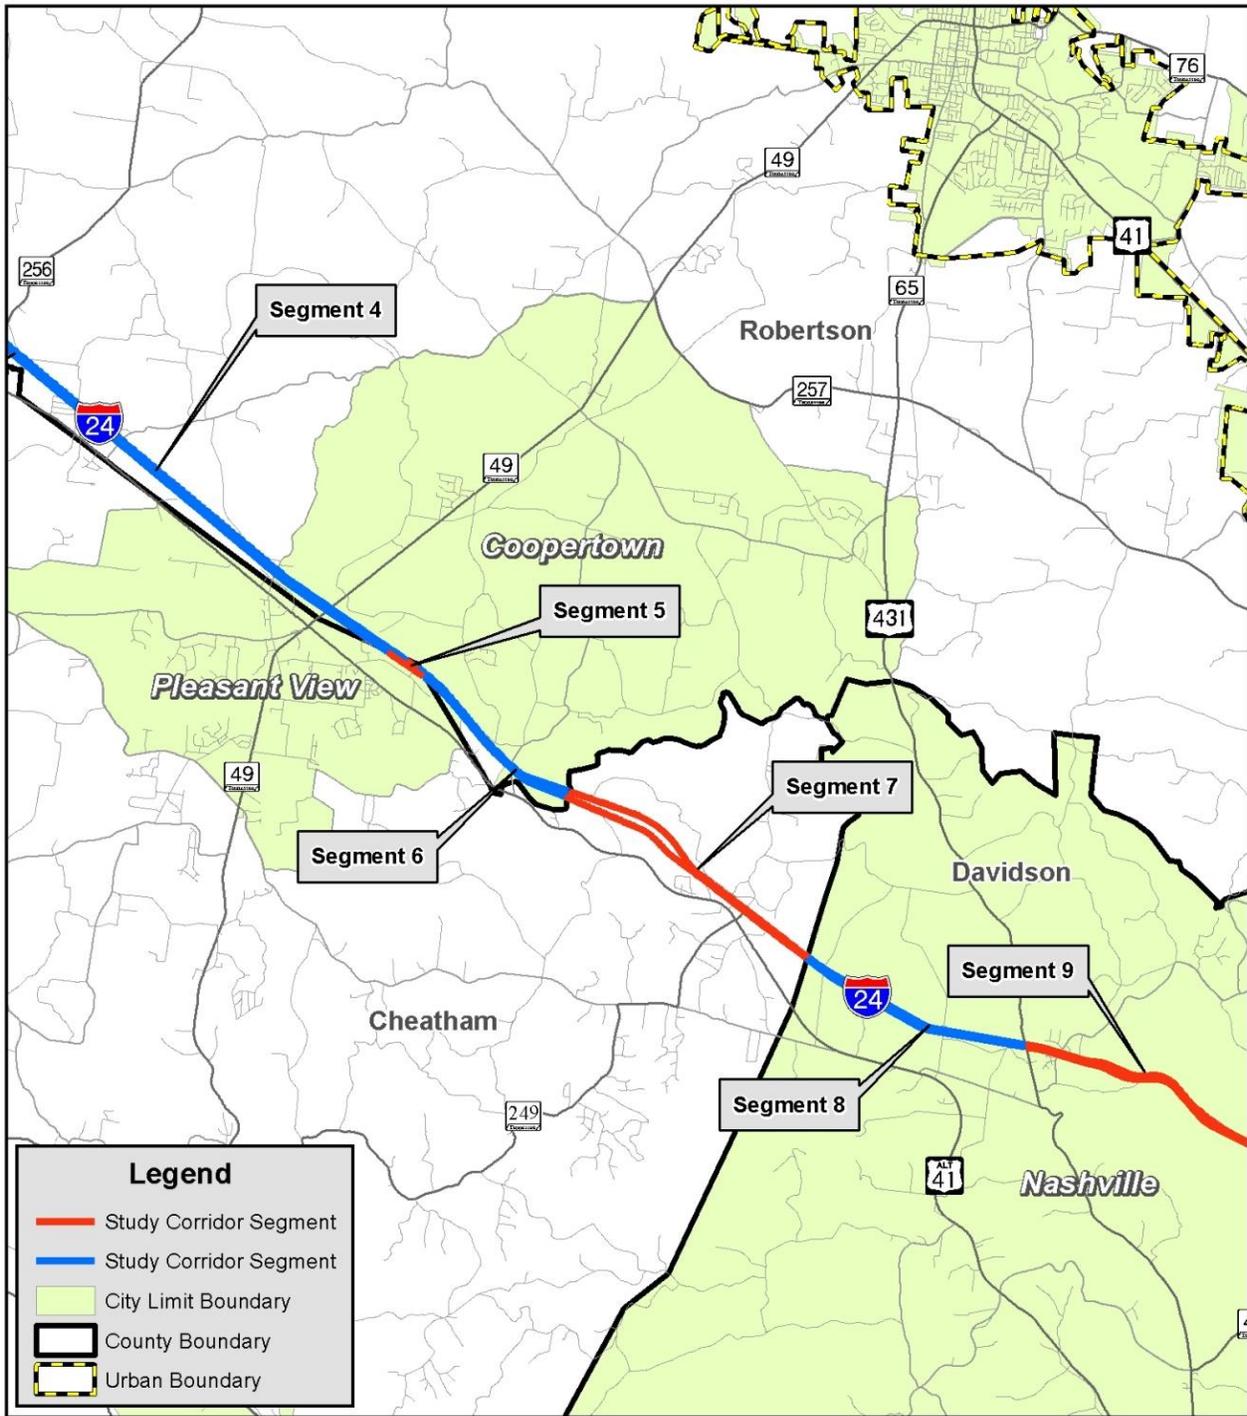
Figure 2.2: I-24 Corridor Segments - Robertson, Cheatham and Davidson Counties

**Interstate 24 Corridor Segments
Robertson, Cheatham, and Davidson Counties**

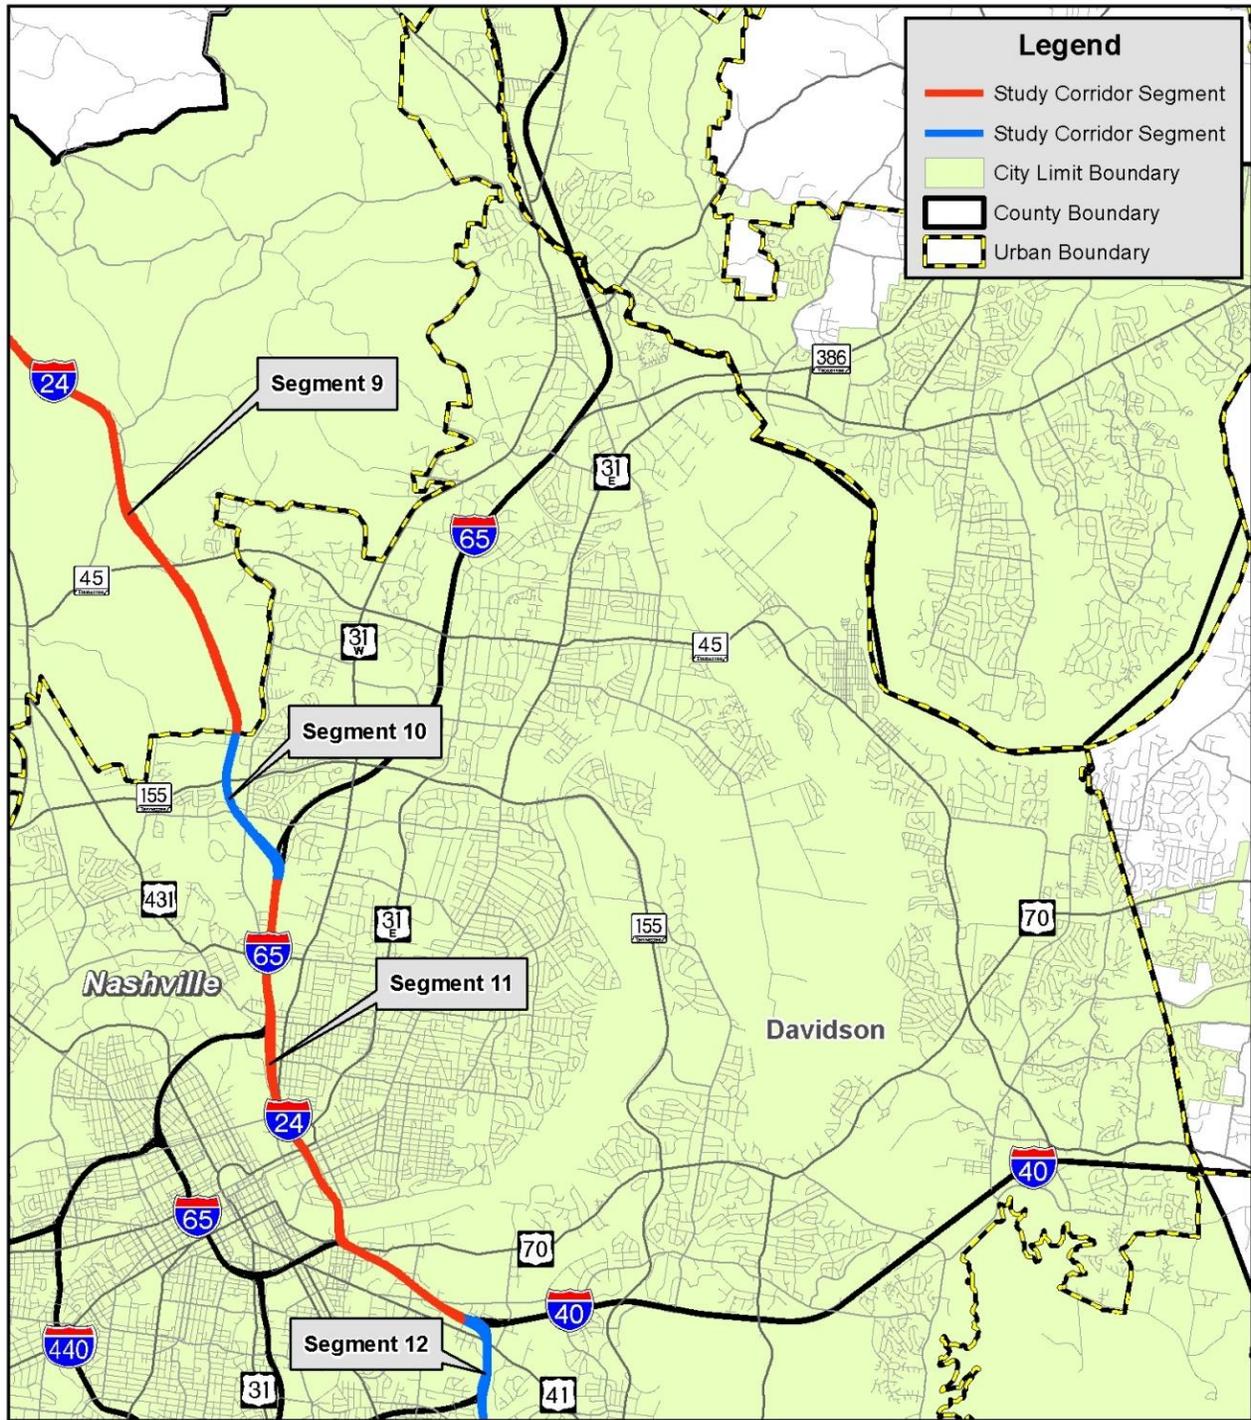
Figure 2.3: I-24 Corridor Segments - Davidson County

**Interstate 24 Corridor Segments
Davidson County**

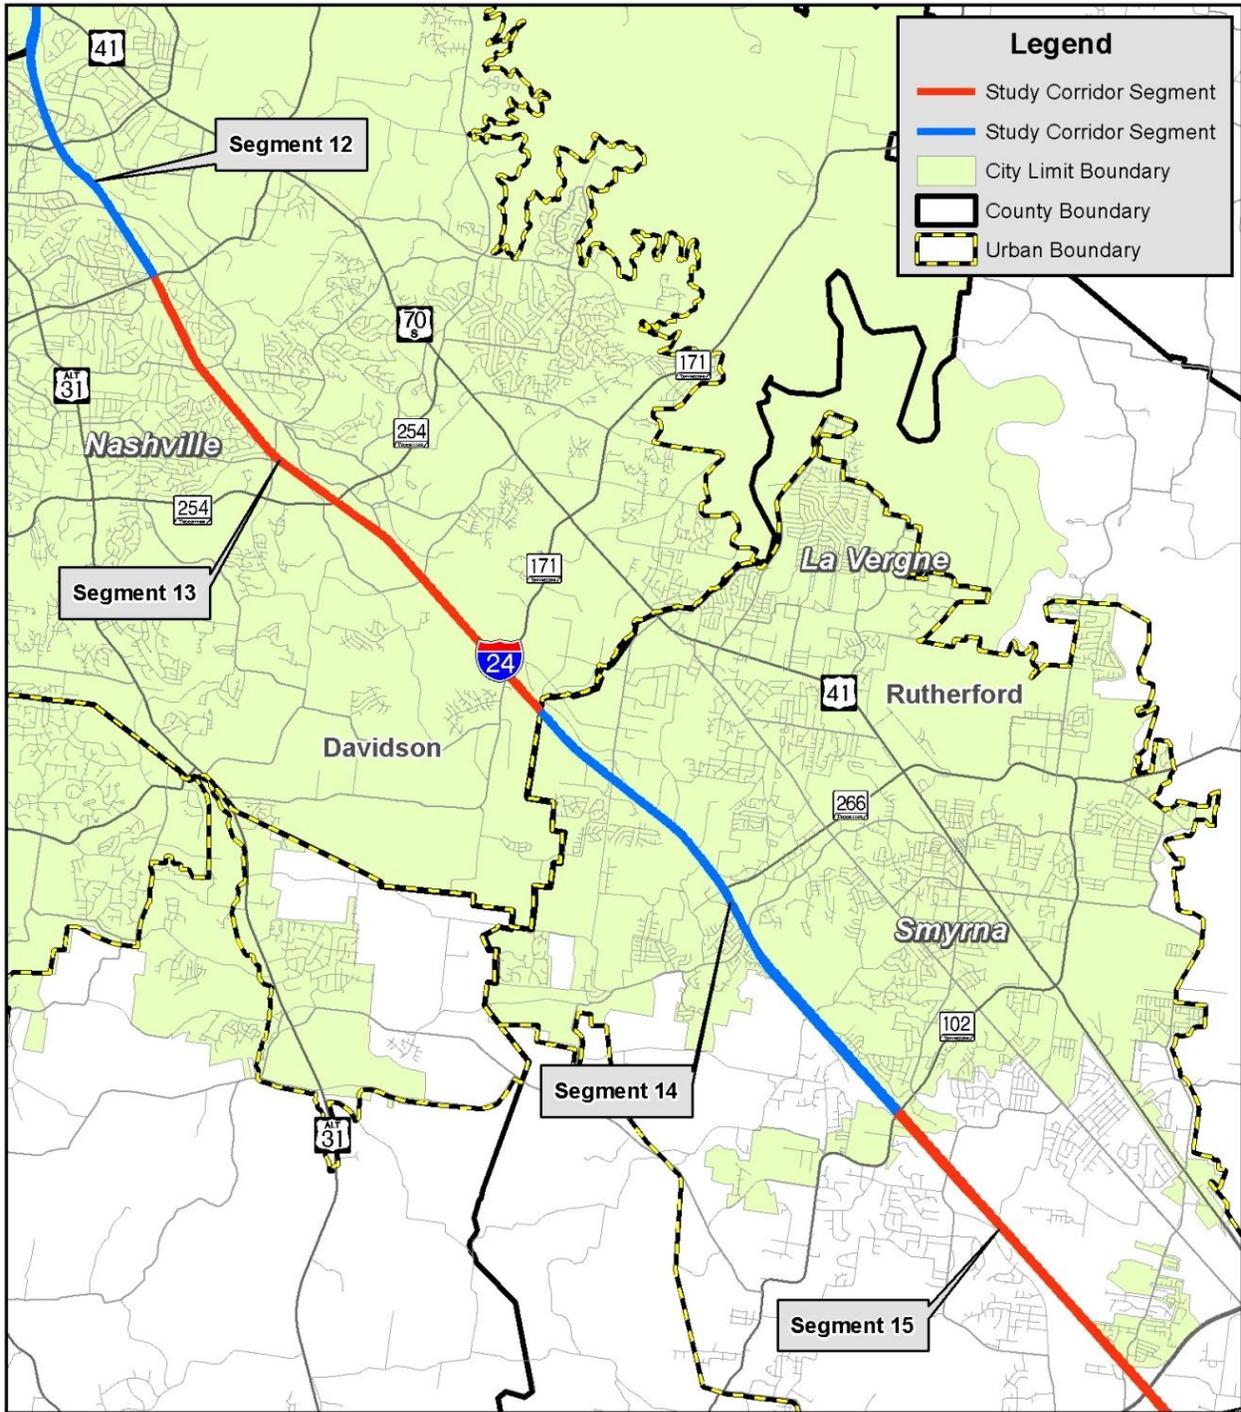
Figure 2.4: I-24 Corridor Segments - Davidson and Rutherford Counties

**Interstate 24 Corridor Segments
Davidson and Rutherford Counties**

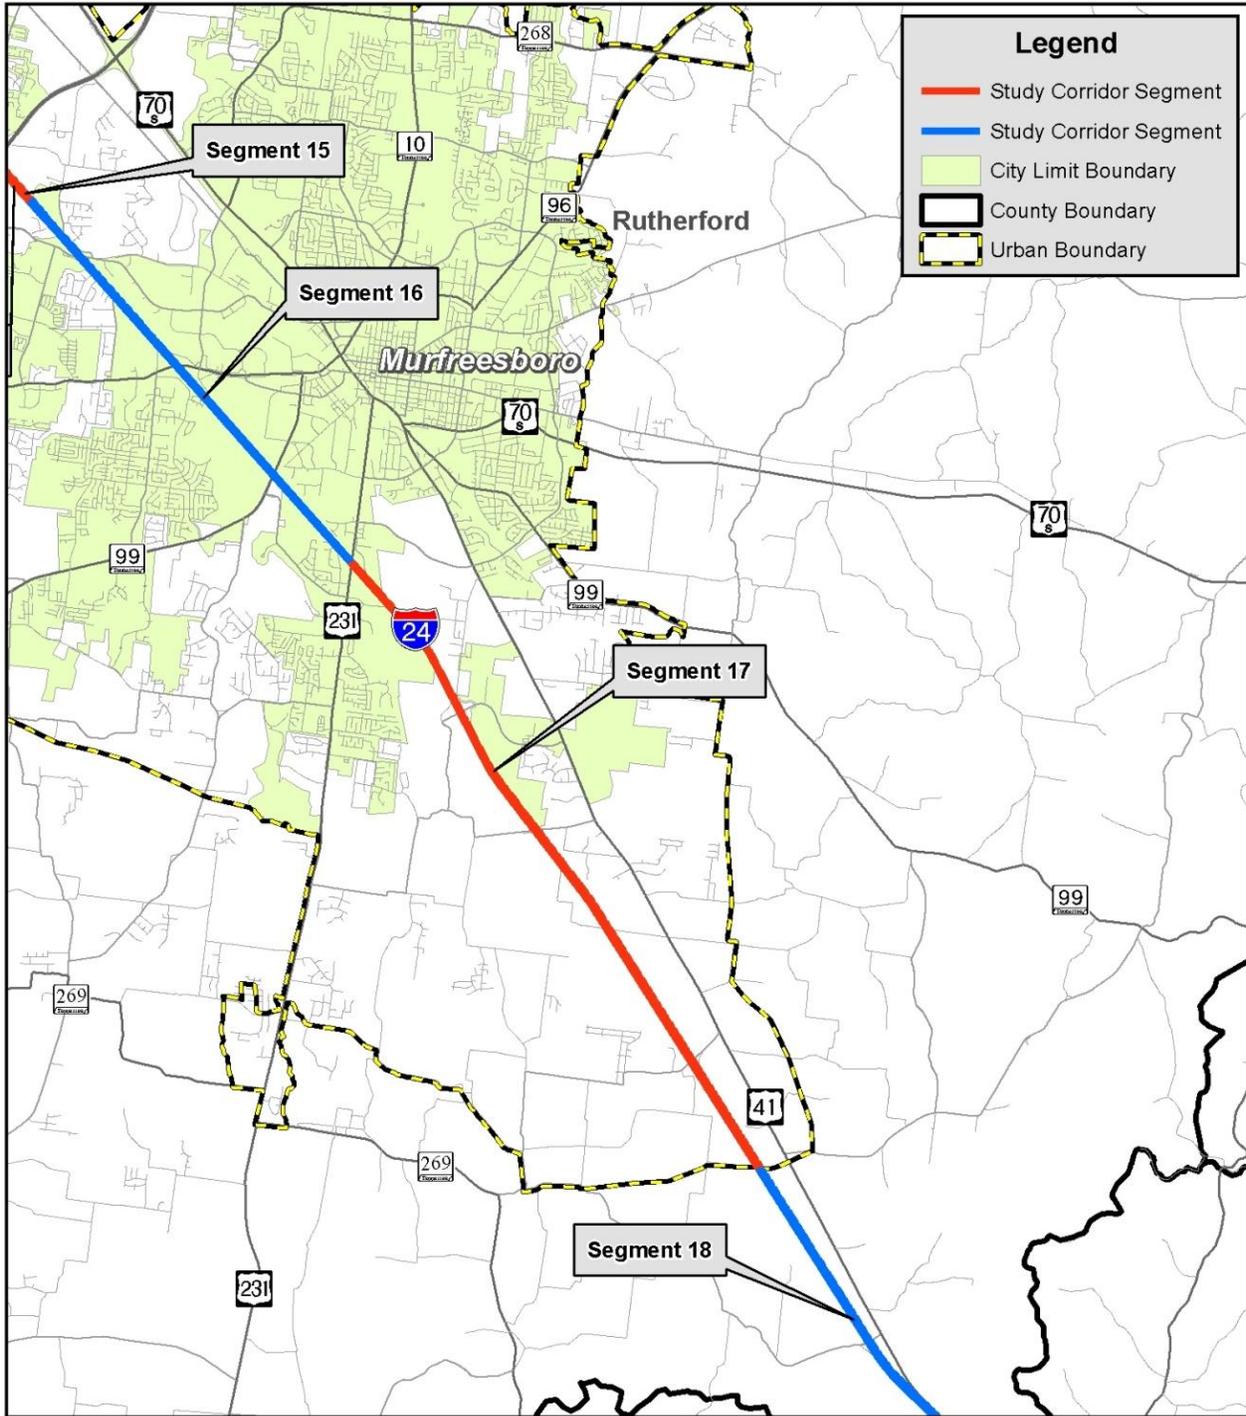
Figure 2.5: I-24 Corridor Segments - Rutherford County

**Interstate 24 Corridor Segments
Rutherford County**

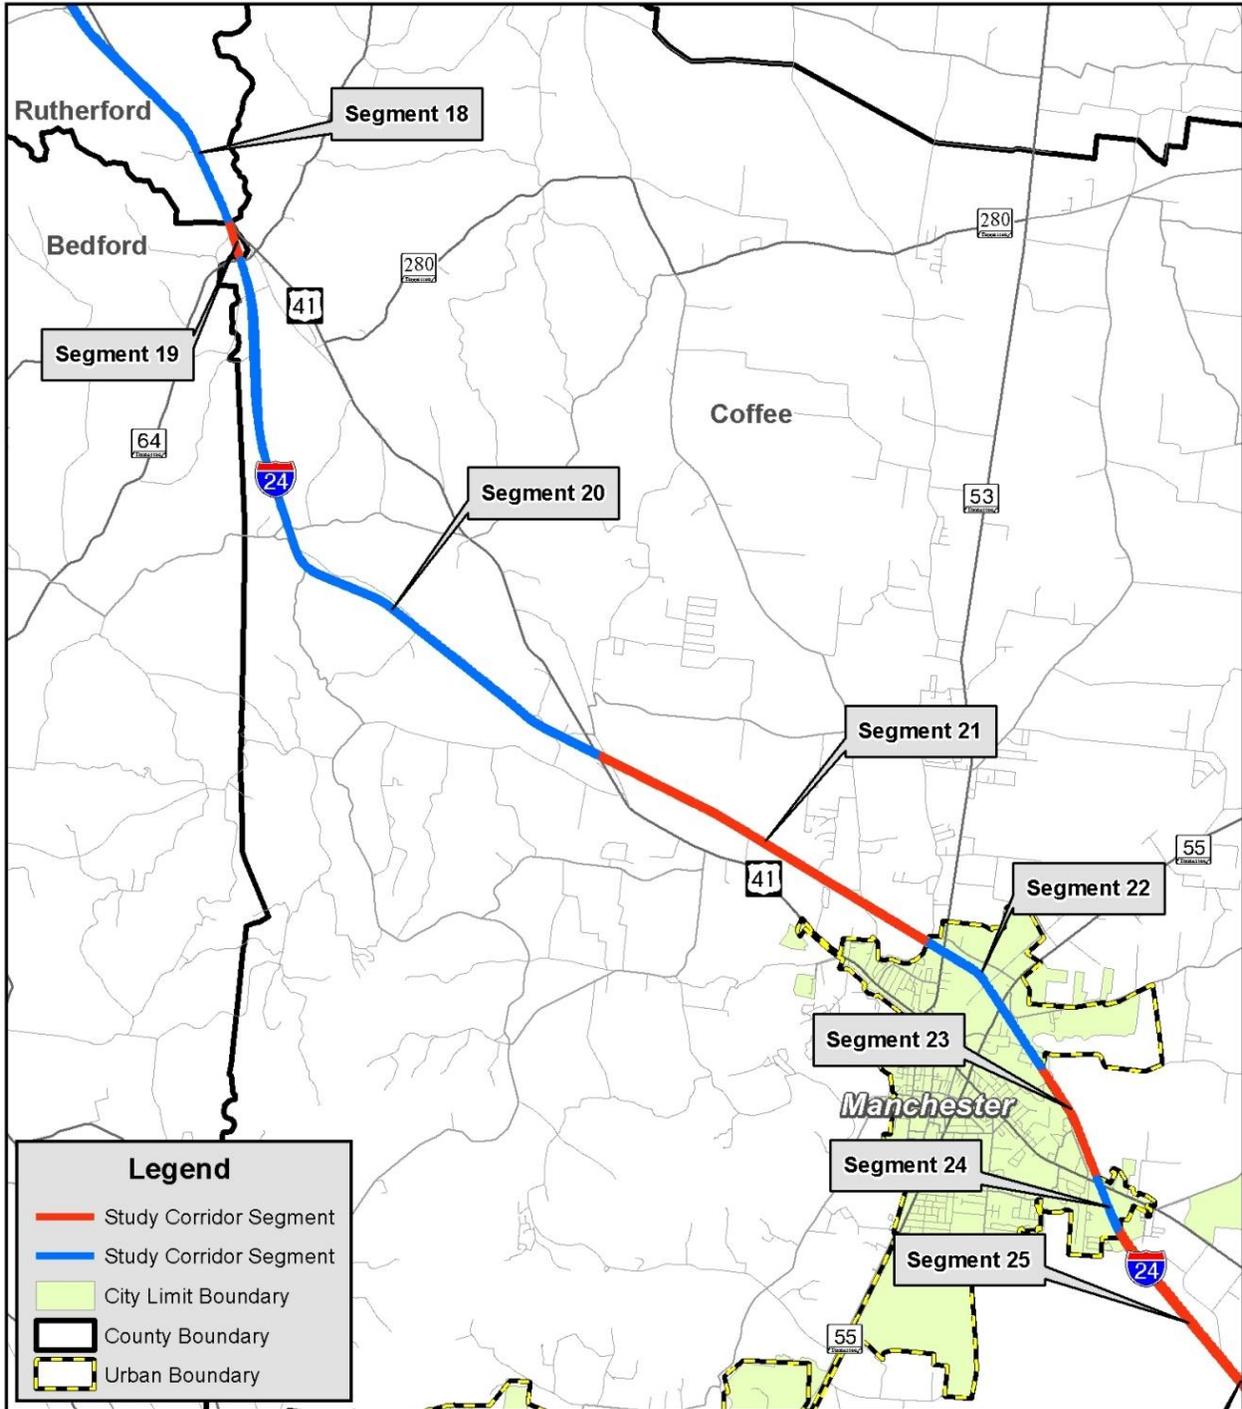
Figure 2.6: I-24 Corridor Segments - Rutherford, Bedford and Coffee Counties

**Interstate 24 Corridor Segments
Rutherford, Bedford, and Coffee Counties**

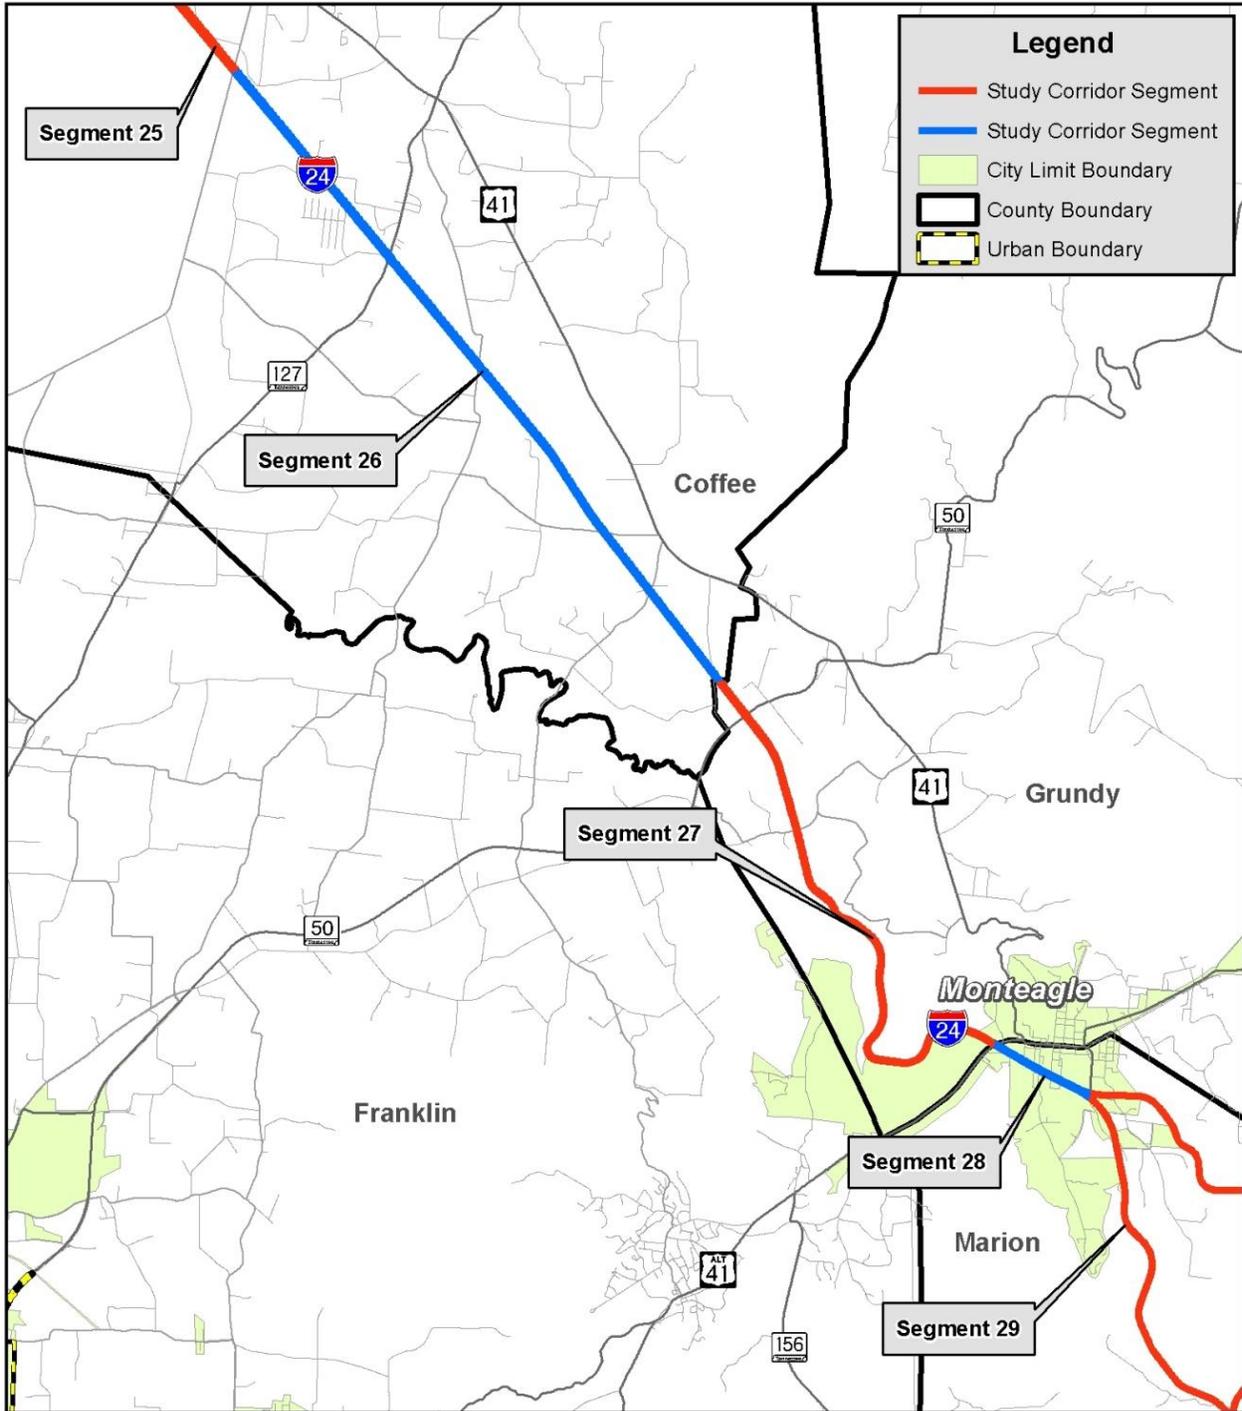
Figure 2.7: I-24 Corridor Segments - Coffee, Grundy and Marion Counties

**Interstate 24 Corridor Segments
Coffee, Grundy, and Marion Counties**

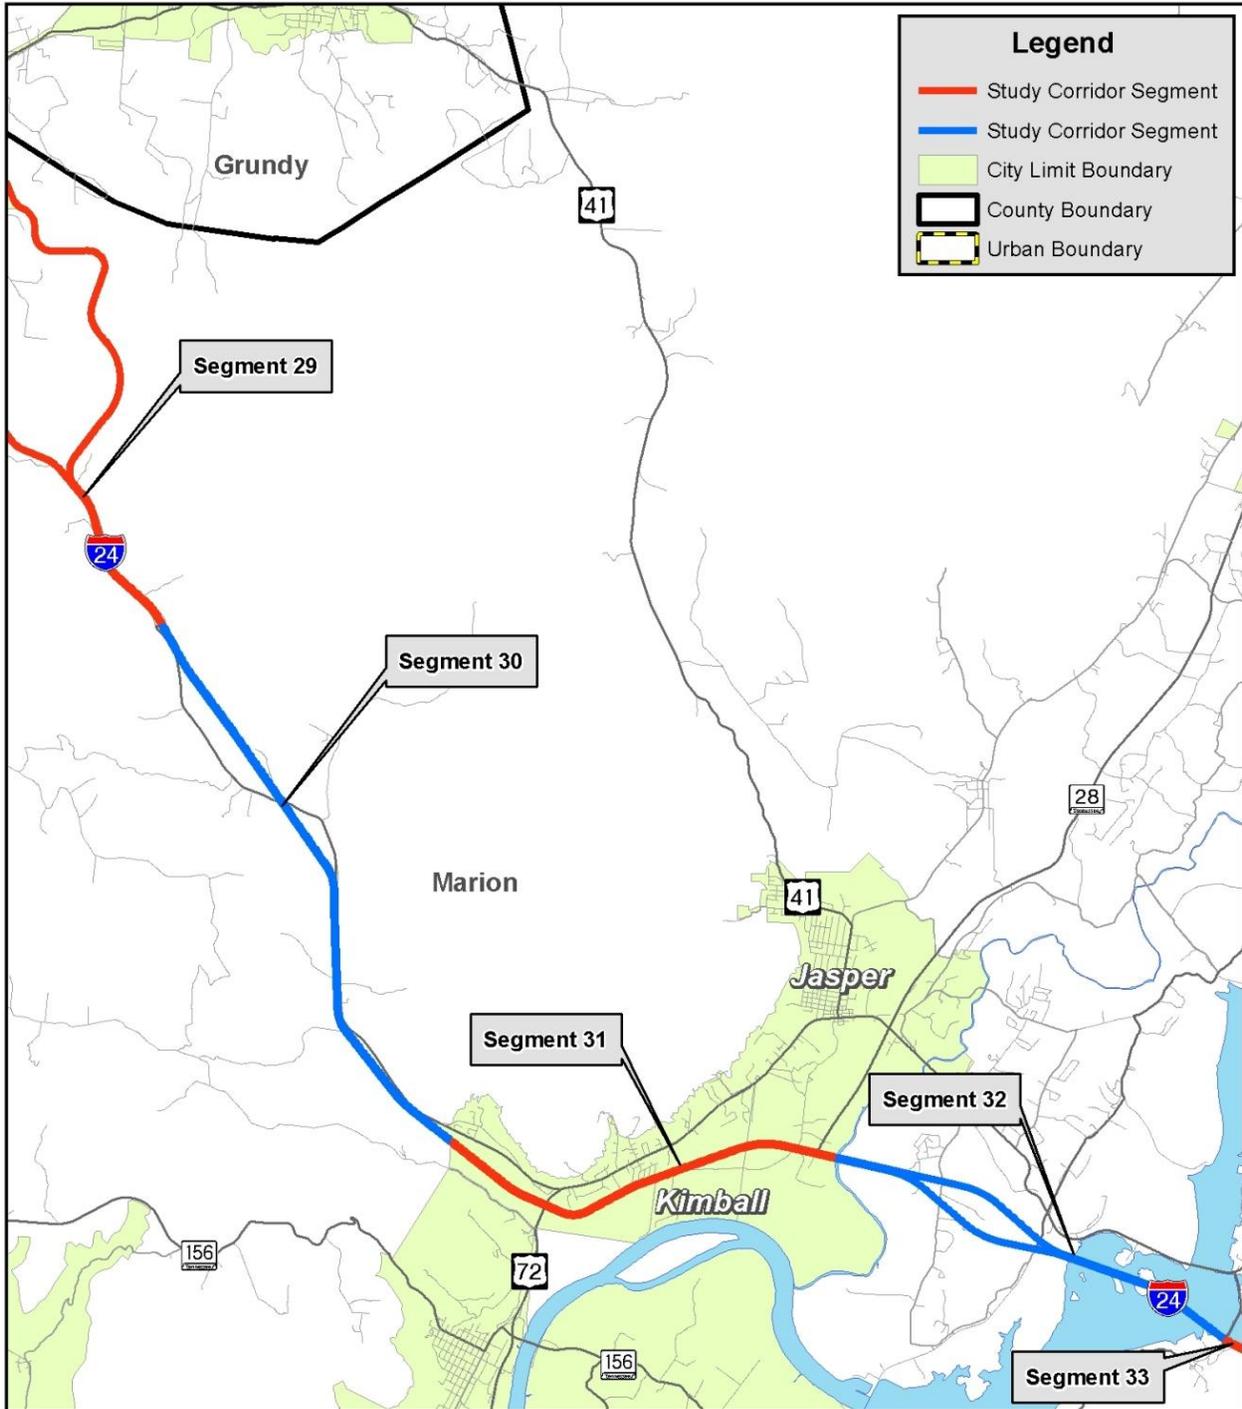
Figure 2.8: I-24 Corridor Segments - Marion County

**Interstate 24 Corridor Segments
Marion County**

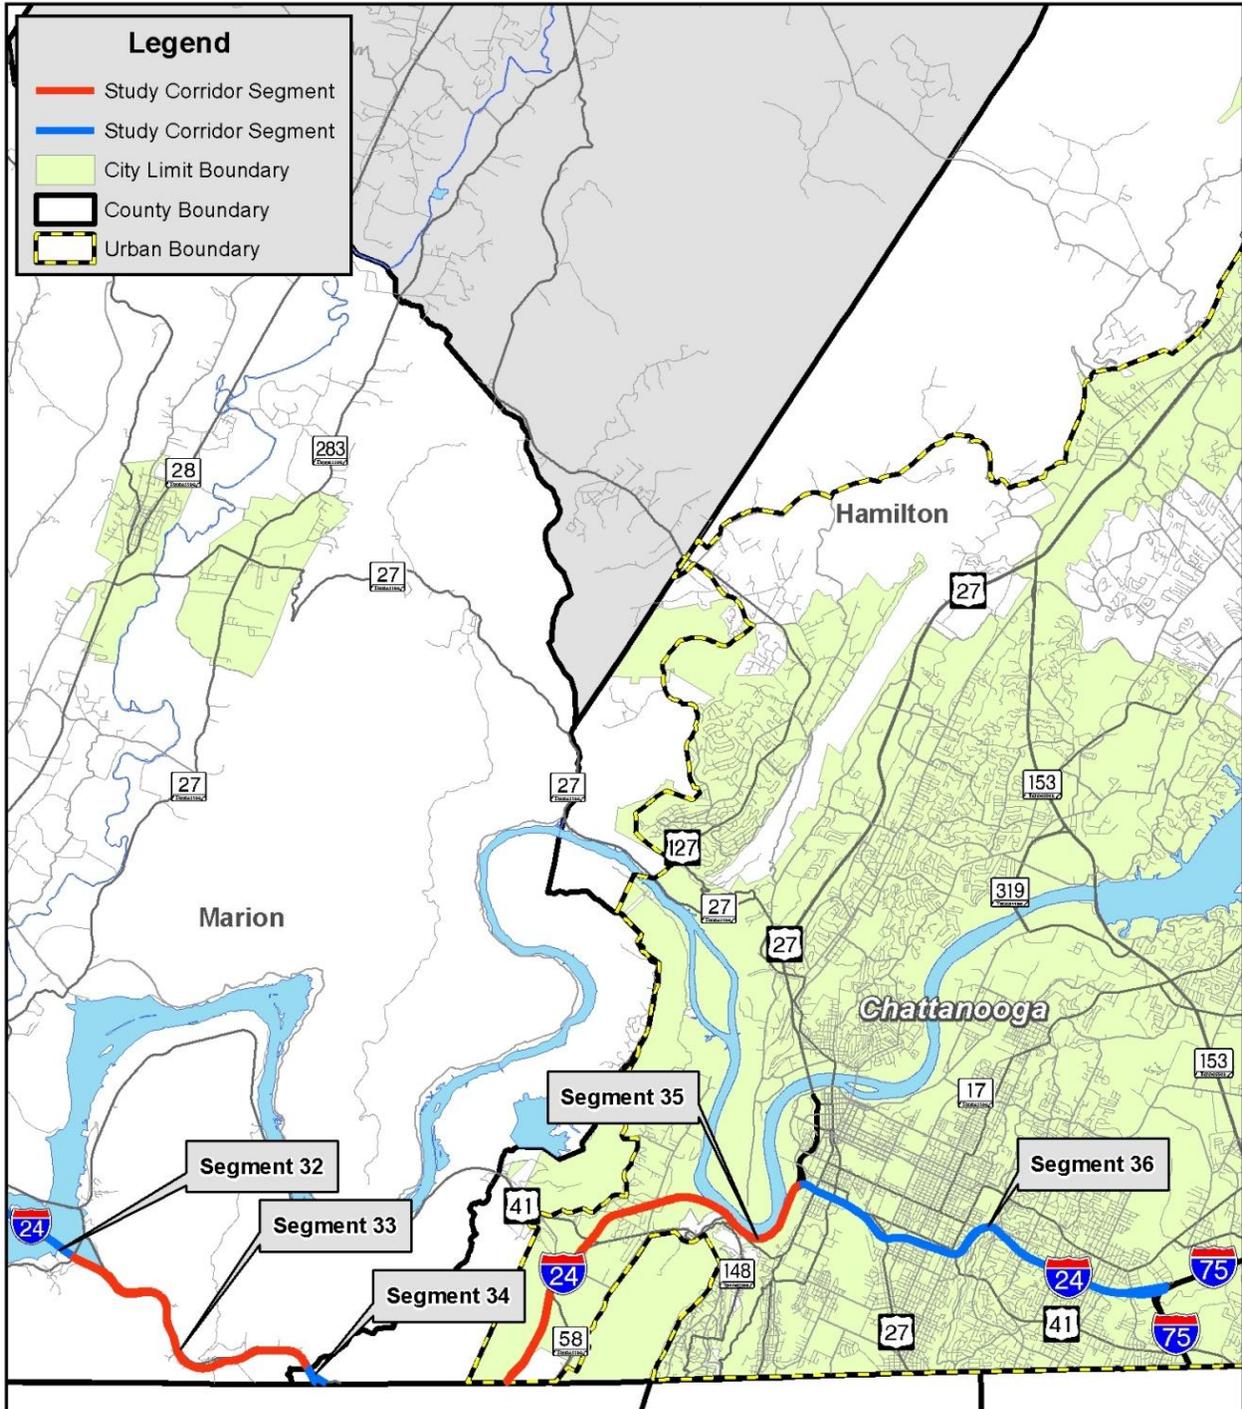
Figure 2.9: I-24 Corridor Segments - Marion and Hamilton Counties

**Interstate 24 Corridor Segments
Marion and Hamilton Counties**
